HISTORIC SITES & STRUCTURES SURVEY
Individual Structure Survey Form

COUNTY:	Chittenden
TOWN:	Jericho
LOCATION:	corner Brown Trace Rd. & Rt. 15
COMMON NAME:	Harley Irish residence
FUNCTIONAL TYPE:	house
OWNER:	Harley Irish, Brown Trace ADDRESS: Rd., Jericho, Vt.
ACCESSIBILITY TO PUBLIC:	Yes <input type="checkbox"/> No <input checked="" type="checkbox"/> Restricted <input type="checkbox"/>
LEVEL OF SIGNIFICANCE:	Local <input type="checkbox"/> State <input type="checkbox"/> National <input type="checkbox"/>

SURVEY NUMBER:	0409-62
NEGATIVE FILE NUMBER:	77-A-59
UTM REFERENCES:	Zone/Easting/Northing 18 662630 4930540
U.S.G.S. QUAD. MAP:	Underhill, Vt.
PRESENT FORMAL NAME:	
ORIGINAL FORMAL NAME:	Joseph Brown-Hiram Day
PRESENT USE:	dwelling house
ORIGINAL USE:	dwelling
ARCHITECT/ENGINEER:	
BUILDER/CONTRACTOR:	
PHYSICAL CONDITION OF STRUCTURE:	Excellent <input type="checkbox"/> Good <input checked="" type="checkbox"/> Fair <input type="checkbox"/> Poor <input type="checkbox"/>
THEME:	
STYLE:	Gothic Revival
DATE BUILT:	ca. 1865

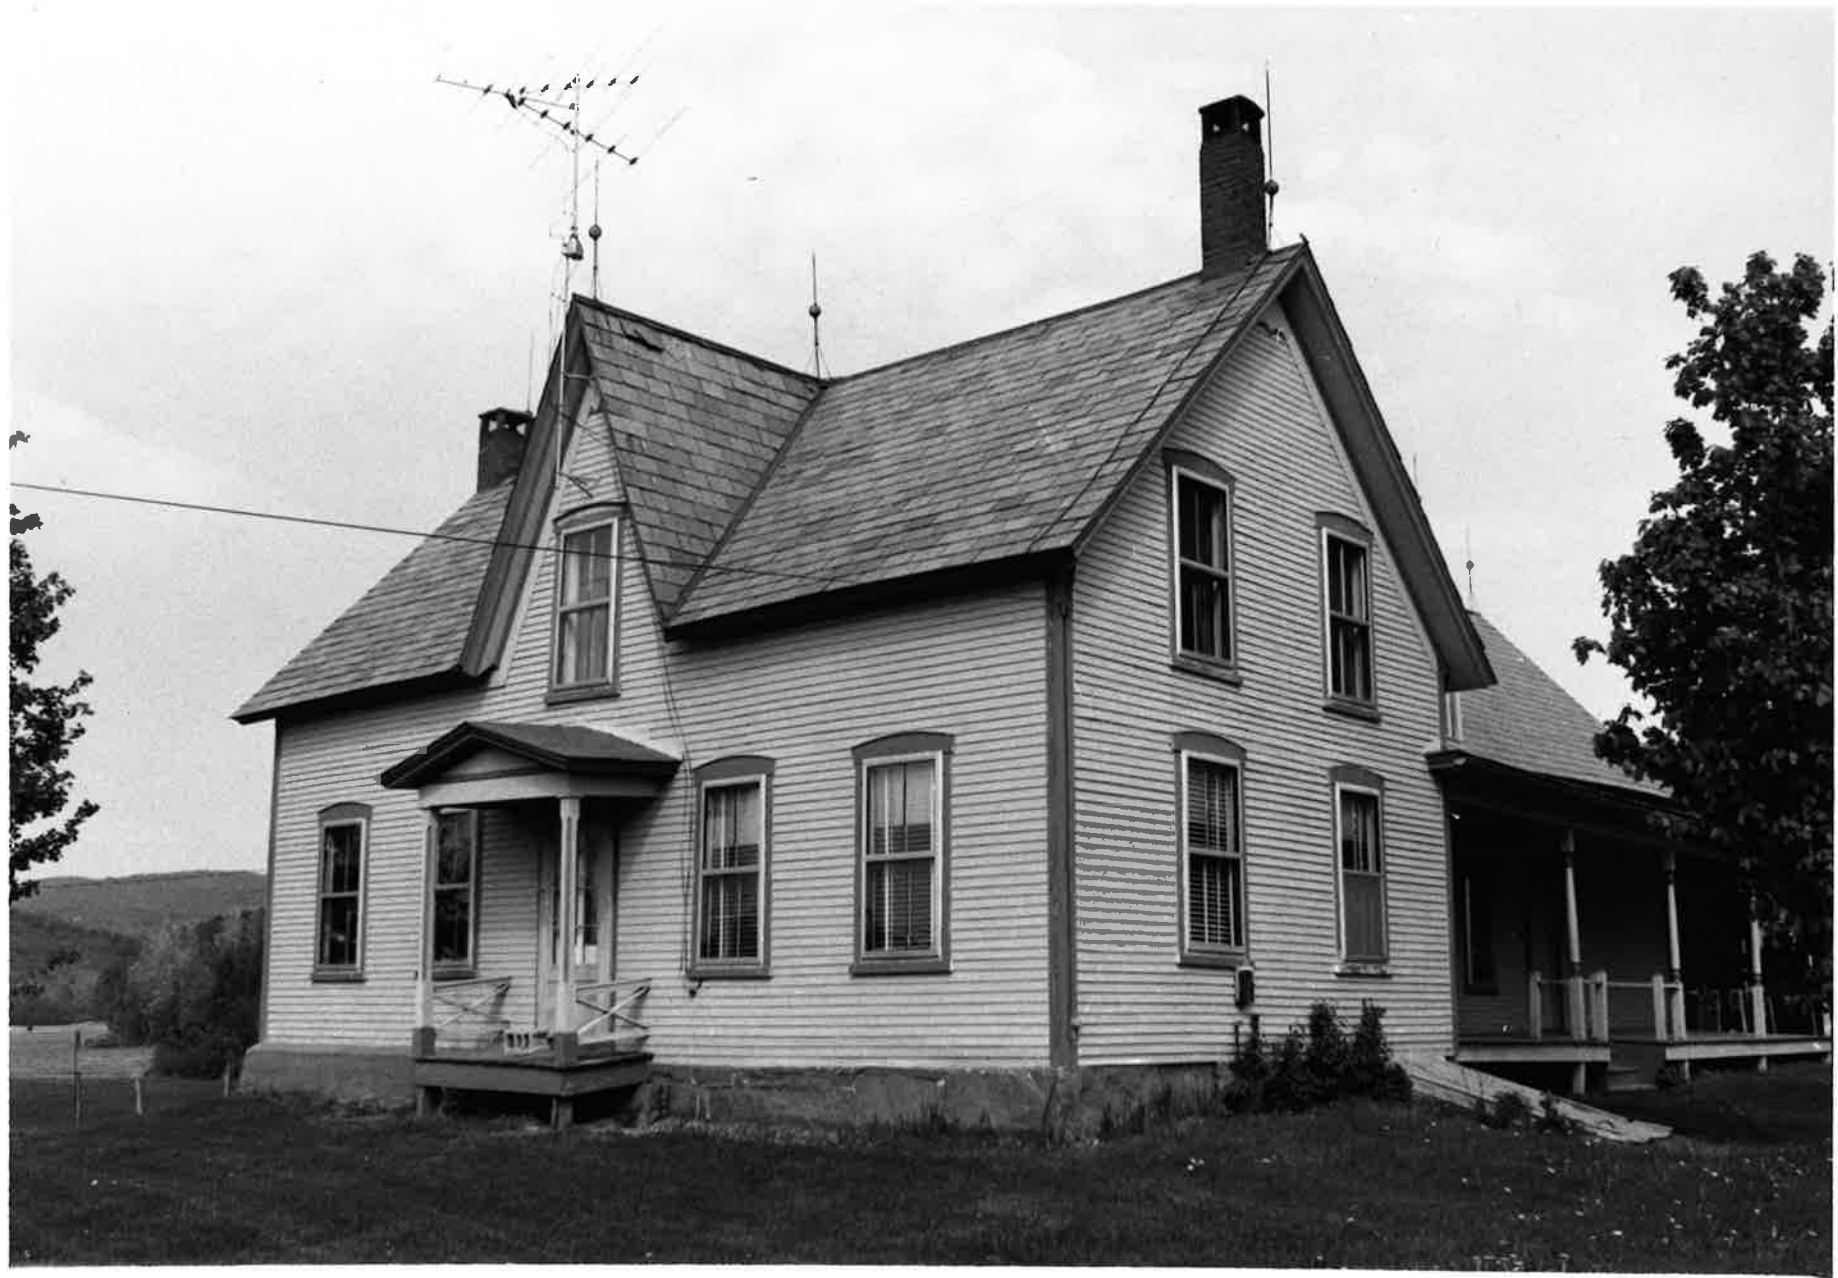
Vt. Div. for Historic Preservation
Chittenden County Jericho 5/77
Harley Irish Residence, 0409.62 NE
77-A-59 Adele Cramer

Window heads are flared and rounded. The centrally located gabled wall dormer is adorned with an arrowhead motif. The door incorporates round arched lights. The entrance porch has chamfered posts and stick style balustrades. 2 dormer windows light the upstairs of the rear wing. The rear porch has turned posts. Vertical plank walls.
